## An Improved Imaging System for Inspecting BGA, CSP, Flip Chip, and Other Hidden Solder Connections

Mark Cannon, President  
ERSA GmbH - Soldering Tools & Inspection Systems  
Leonhard-Karl-Str. 24, D-97877 Wertheim, Germany

This article was originally published in the Proceedings of APEX, March 2000.

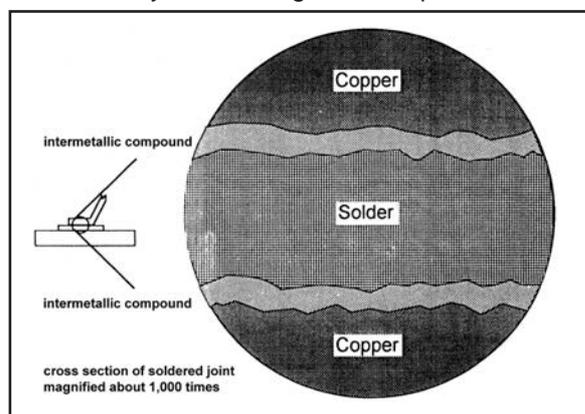
Figure 1 - The Heart of the Solder Joint

between a copper lead and a copper land. The lasting mechanical connection is achieved via the process of soldering. Tin-lead or solder is introduced to the lead/land junction and is then heated above the melting point. When sufficient activation energy is present, a chemical diffusion reaction ensues, which creates an intermetallic bond between the copper in the lead and tin in the solder and subsequently between the tin in the solder and the copper in the land. When properly created, a soldered connection will last a very long time or better put, sufficiently beyond the warranty period of the product. The heart of the solder joint is shown in Figure 1<sup>2</sup> and is detailed in Figure 2<sup>3</sup>.

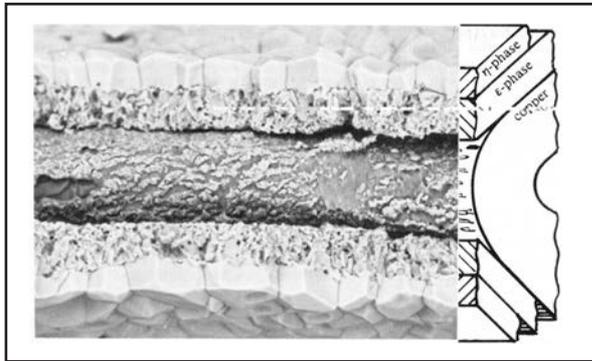
Figure 2 – Scanning Electron Micrograph (SEM) of Fractured Intermetallic Layers of a Solder Joint. Cu<sub>3</sub>Sn (e-phase) and Cu<sub>6</sub>Sn<sub>5</sub> (n-phase) Make Up the Inter-metallic Layers.

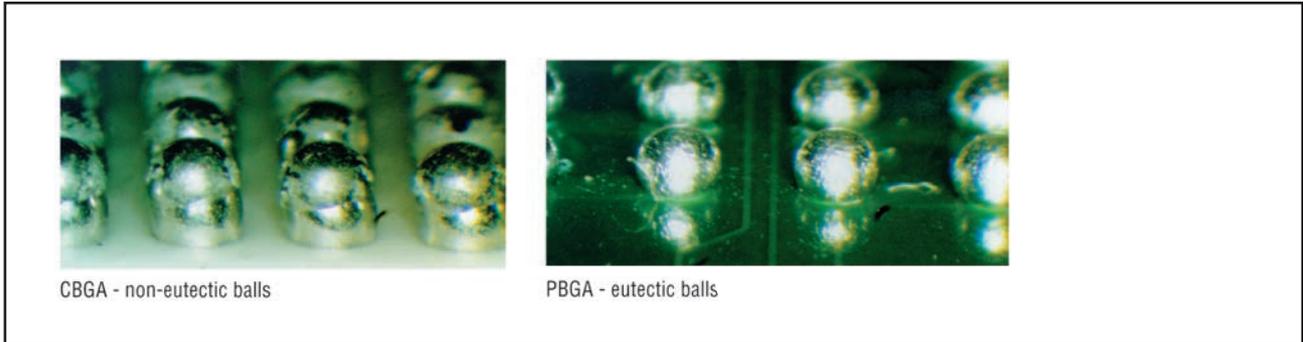
Figure 3 – Ball Comparison Photos

In general, eutectic solder balls (Sn63Pb37) are always used for area array packages except in the case where the weight of the component is greater than the surface tension of the molten balls during reflow. A CBGA (ceramic BGA) is a typical example of a component that could not be "carried" by the surface tension of the solder balls during the reflow process. In this case, a high melt ball, for example Pb90Sn10, is used because it will remain solid during the normal reflow process. Figure 3 and Figure 4 detail the different wetting zones, and wetting angles between a PBGA and a CBGA and their respective joints.

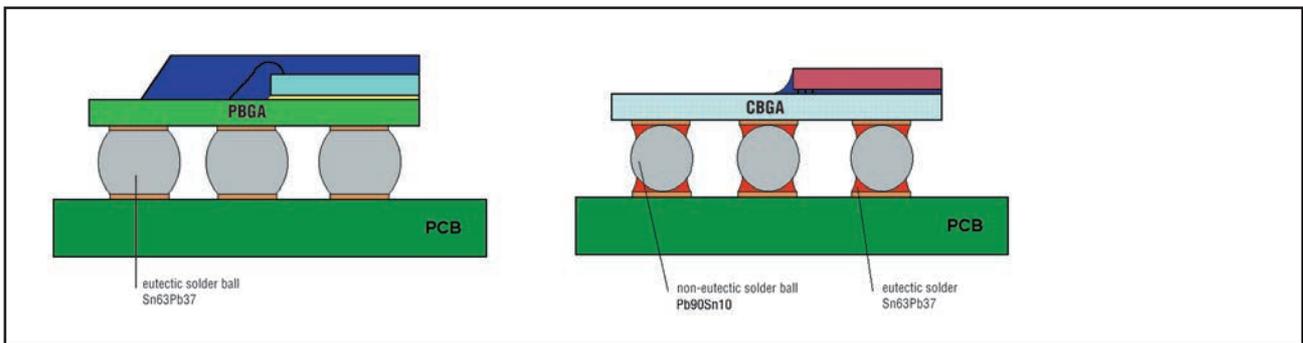
Figure 4 – Comparison of Installed PBGA to a CBGA

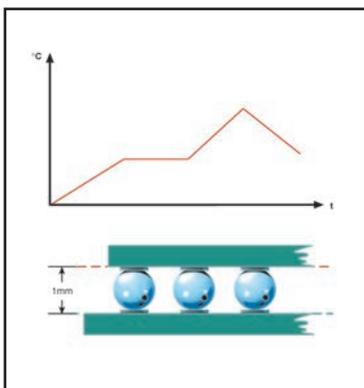
Figure 5 – Condition A  
Before Reflow Begins

The typical physical effects during the reflow soldering process of a PBGA are graphically shown in Figures 5, 6, and 7, with regards to the stand-off height and wetting angle.

After placement of the component onto the fluxed pad or into the solder paste print, a stand-off height measurement can be taken; in the example in Figure 5, the stand-off height is 1 mm. During the reflow process, and after the flux has been activated, the melting point 183°C of the eutectic solder balls (Sn63Pb37) is reached; e.g. the balls move from the solid to the liquid state. Gravity acts on the component causing an initial or single drop. The stand-off height could be checked at this point in order to determine the amount of the initial drop; in the example shown in Figure 6, the drop can be calculated as 0.2 mm. As the reflow process continues toward the peak temperature, sufficient activation energy allows for a complete wetting of the solder spheres to the entire pad profile. This results in a measurable second or double drop, depicted in Figure 7, which amounts to 0.3 mm. A cross-section of a PBGA 225 after a proper reflow process, as seen in Figure 8, shows the complete wetting to the pad and the proper wetting angle of the flux residue fillets.

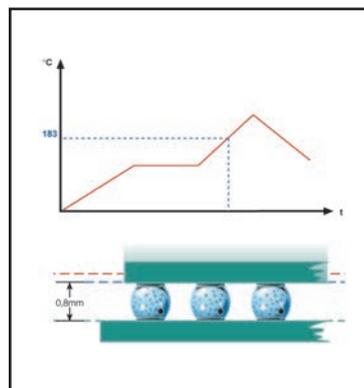
Figure 6 - Condition B  
At Solder Melt Point

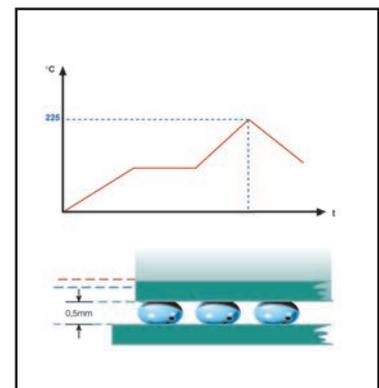
Figure 7 - Condition C  
At Proper Peak Temperature

During a proper or complete reflow process as depicted graphically in Figure 7 and again in Figure 11, sufficient heat has been provided which allows for the formation of the intermetallics. This intermetallic bond is stronger than the epoxy bond between the pad and the substrate. A pull test of a properly soldered component would result in the pads ripping off the substrate. This result can be seen in Figure 12. While such a pull test can provide an indication of expected reliability, by proving the existence of an intermetallic, it is destructive and can only be used on a limited basis. A cold solder joint, as seen in Figure 9, if undetected, can prematurely fail due to either an oxidation layer build-up between the ball and the pad, or due to sheering caused by the stress of CTE (Coefficient of Thermal Expansion) mismatch during thermal cycling. This latter problem is seen most often with CBGA and CCGA components based on the inherent CTE mismatch problems associated with the ceramic material and the substrate. The ability to determine whether the reflow process delivers the quality results as seen in Figure 11, and not the cold joint as seen in Figure 9, must be a part of the total quality assurance associated with first article inspection.

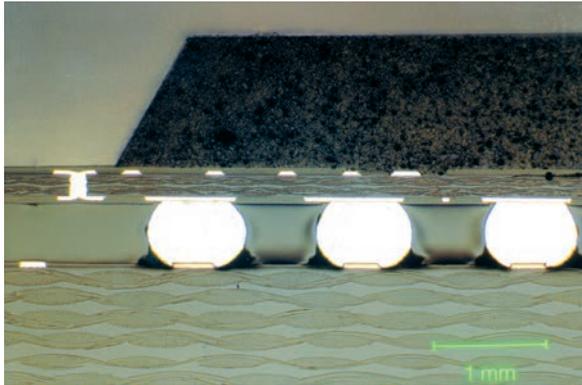
Figure 8 – Cross-section of PBGA 225 after Soldering<sup>4</sup>

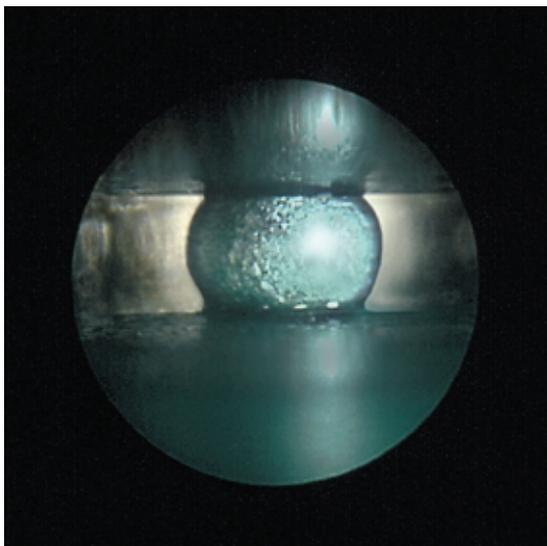
Figure 9 - Cold Solder Joint in Condition B: Initial or Single Drop

A hidden production deficiency associated with BGA production must be discussed and relates to insufficient heat and cold solder joints. Typically, cold solder joints are discovered via a visual examination of the assembly after the reflow process. This non-destructive inspection, however, has not been possible with the hidden joints found under an area array package. The danger of leaving a cold joint undetected can be proven by using a destructive method. A pull test to determine the lasting mechanical reliability of a solder joint would reveal that if the BGA reflow process stopped during Condition B, single drop, as seen graphically in Figure 6 and again in Figure 9, the joint would shear off at the solder ball-pad interface. The primary force holding the component balls to the lands is cohesion. This force is generally not greater than the epoxy bond of the pad to the substrate and would therefore result in such sheering as depicted in Figure 10.

An electrical function test alone can provide no answer as to the long term reliability of an electronic assembly. The cold solder joint depicted in Figure 9 would clearly pass a function test for opens or shorts as a proper electrical connection has been established. Additionally, a short term mechanical connection has been established based on the surface tension or cohesive force that causes the ball to fix to the pad. Life cycle tests, however, will reveal premature failure of such cold joints as previously discussed.

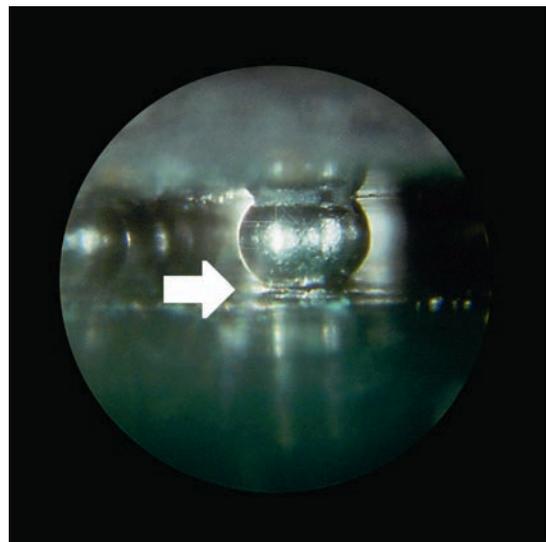
Figure 10 - Pull Test Result of a Cold Solder Joint in Condition C: Second or Double Drop

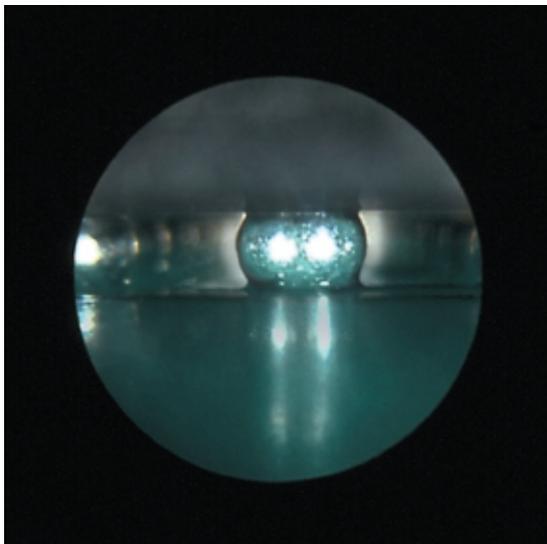
Figure 11 - Good Solder Joint in Condition C:  
Second or Double Drop

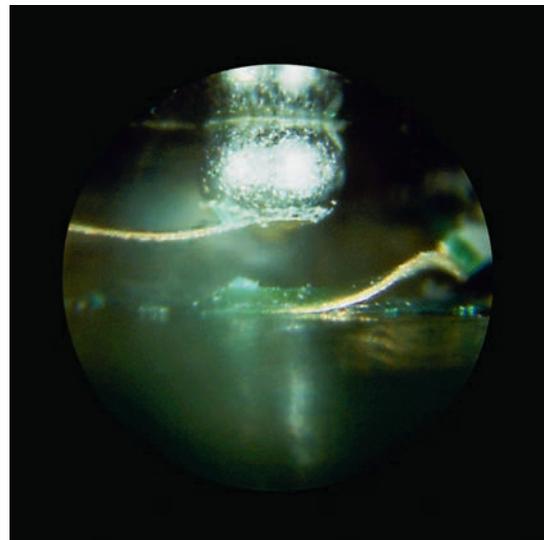
Figure 12 - Image of Pull Test of Good Solder Joint

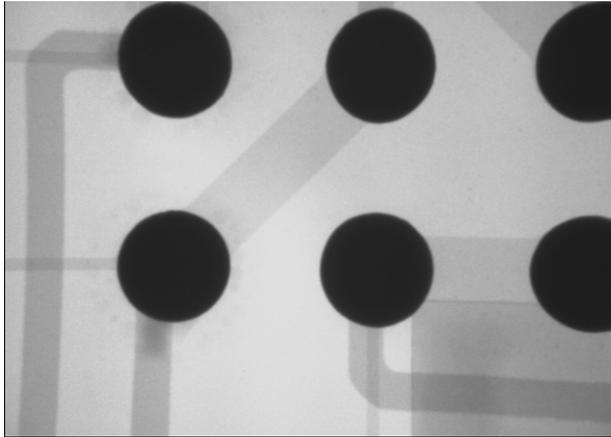
Figure 13 – X-ray Image of BGA-Top View

With regards to inspection, X-ray has established itself as the primary method for non-destructive both in-line and off-line inspection of hidden solder joints, particularly those of BGA, CSP, and Flip-Chip components. When considering the 4 critical visual inspection areas listed in Table 1, which operators have been looking for over the years, the shortcomings of the technology become apparent. In general, X-ray equipment can inspect for two of the four areas listed in Table 1: the quantity of solder in the joint, the ball and/or fillet shape, the alignment, and for voids. Figures 13 and 14 reveal two examples of the information available from typical X-ray systems.

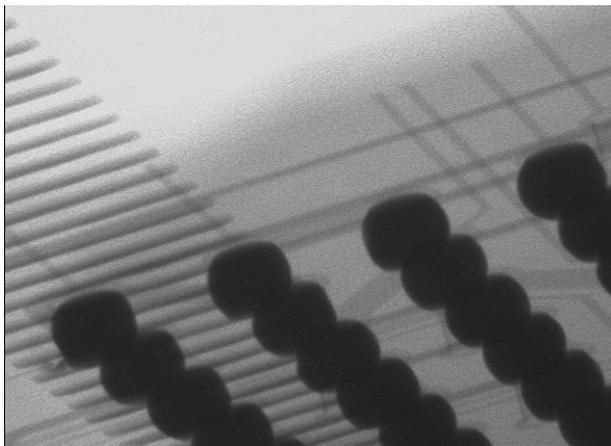
Figure 14 – X-ray Image of BGA-Angled View

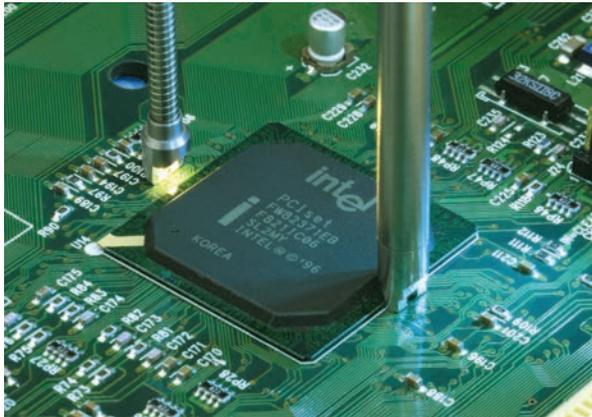
Figure 15 – Optical Instrument

The optical solution presented here and as depicted in Figure 15 is an innovative advancement on existing medical and technical endoscopy.

This optical instrument (patent pending) combines integrated split fibre optics, and a total of 42 lenses optically coupled to a highly specialized prism with an optical axis tolerance of less than 2° seconds. The resulting image offers up to 700x magnification of the soldered connections under a Flip-Chip even with a stand-off height of less than 0.05 mm (2 mils). Put into practice, the advantage of this optical system becomes apparent. Figures 16, 17, and 18 address the differing information gained from an X-ray system versus the optical imaging system.

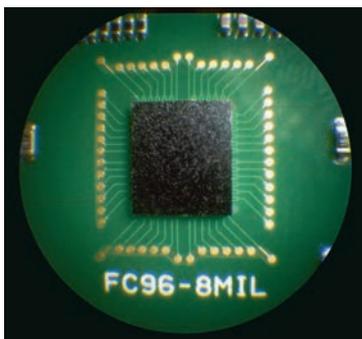
Figure 16 - Flip Chip 96 After Soldering,  
Before Underfill, Stand-Off 0.05 mm

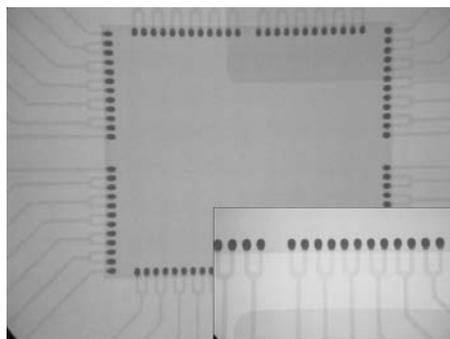
Figure 17 - X-ray Image of Flip Chip 96  
After Soldering, Before Underfill

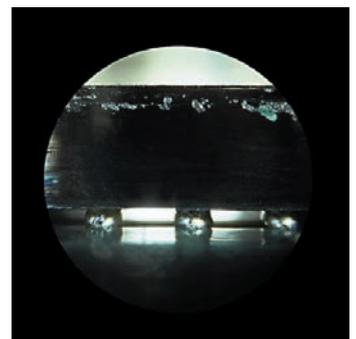
Figure 18 - Image of Flip Chip 96  
After Soldering, Before Underfill

It is essential to have total quality assurance for a Flip Chip soldering process. Once the Flip Chip receives its underfill, it cannot be removed from the PCB. The premature failure of this one component would lead to the scraping of the entire PCB. The image seen in Figure 18 can be regarded as an expansion to current inspection technology in that it provides additional and valuable information about the soldering process.

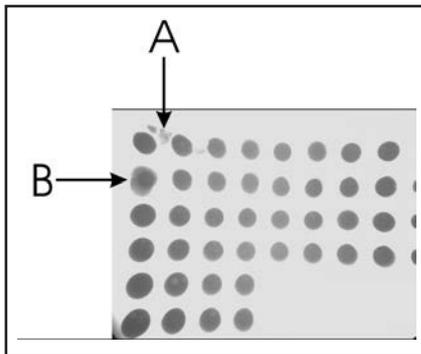
Figure 19 - X-ray Image of PBGA 225:  
A and B are Unclear of Source

Additionally, an optical imaging system can greatly enhance X-ray by offering a visual image of those problems picked up by both in, and off line X-ray systems. An installed PBGA 225 was X-rayed as seen in Figure 19. It is quite clear that the areas marked A and B in Figure 19 are not ideal. It would be difficult, however, using only the X-ray image to identify the source of the problem in order to correct it. Going hand-in-hand with X-ray, the optical imaging system provides this missing capability for failure analysis. Figures 20 and 21 reveal how the additional visual information can be used in conjunction with the X-ray image seen in figure 19 to get to the heart of the problem in order to correct it.

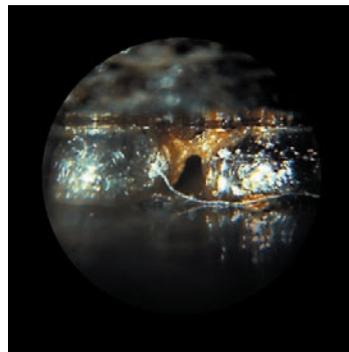
Figure 20 - A. Image Reveals Flux  
Residue Bridge with Conductive Particles

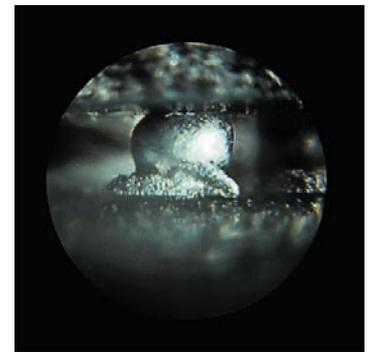
Figure 21 - B. Image Shows  
Incomplete Solder Melt of Paste

Instead of removing and scraping a perfectly good BGA component, the improved imaging system could better guide the repair process. The problem shown in Figure 21, for example, could be easily fixed via a controlled secondary heating using an appropriate repair system.

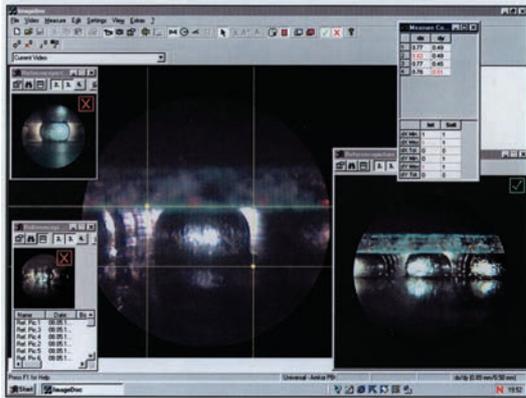
Figure 22 – Measurement and Quality Control Software

Inspection, as it pertains to quality control, combines two critical aspects: to see and to evaluate. The first, is the ability to properly and completely see the object to be inspected. The second, is the inspector's analysis or evaluation of that which he or she sees as being good or bad. Both go hand-in-hand and are critical to the success of an inspection program. In order to assist in the failure recognition process of analyzing information gained from the improved imaging system, a quality control software was written. Figure 22 depicts an inspection example of a typical BGA using the linked software.

In addition to displaying a real time video of those images captured by the optical system, the user can call up good/bad reference pictures as windows or overlays. Component, board, or error-specific reference picture groups can be accessed from the online databank in order to minimize the occurrence of improper evaluation. With the system optically calibrated distance, angle, radius, and point-to-point measurements can be taken with an accuracy of  $\pm 0.01$  mm. Stand-off height, wetting angle, ball radius, and co-planarity measurements can extend the capability of the visual indicators to ensure a more complete and objective inspection process. An automatic measure control function provides a "go"/"no go" based on the automatic comparison of actual and target measurement values which can be stored in a separate measure control databank by the Quality Control Manager. Images and corresponding measurement values can be stored in the main image databank with sub-files containing all pertinent information about the parameters involved in the process, e.g. type of flux, paste, temperature profile, etc. Once a failure or problem is noted via the use of the reference pictures, a online problem/solution databank will present a complete description of the problem, its probable causes, and potential remedies to cure the problem. Images, files and databank information can be printed in document form or sent via e-mail. When used in conjunction with the improved imaging system for BGA inspection, the linked measurement and control software can greatly aid in failure recognition by reducing the subjectivity of the inspection process in order to guarantee total quality assurance.
